BEIRUT

— OPEN SPACE POST- DISASTER DAMAGE AND PRE-DISASTER CONDITION ASSESSMENT

SEPTEMBER 2020

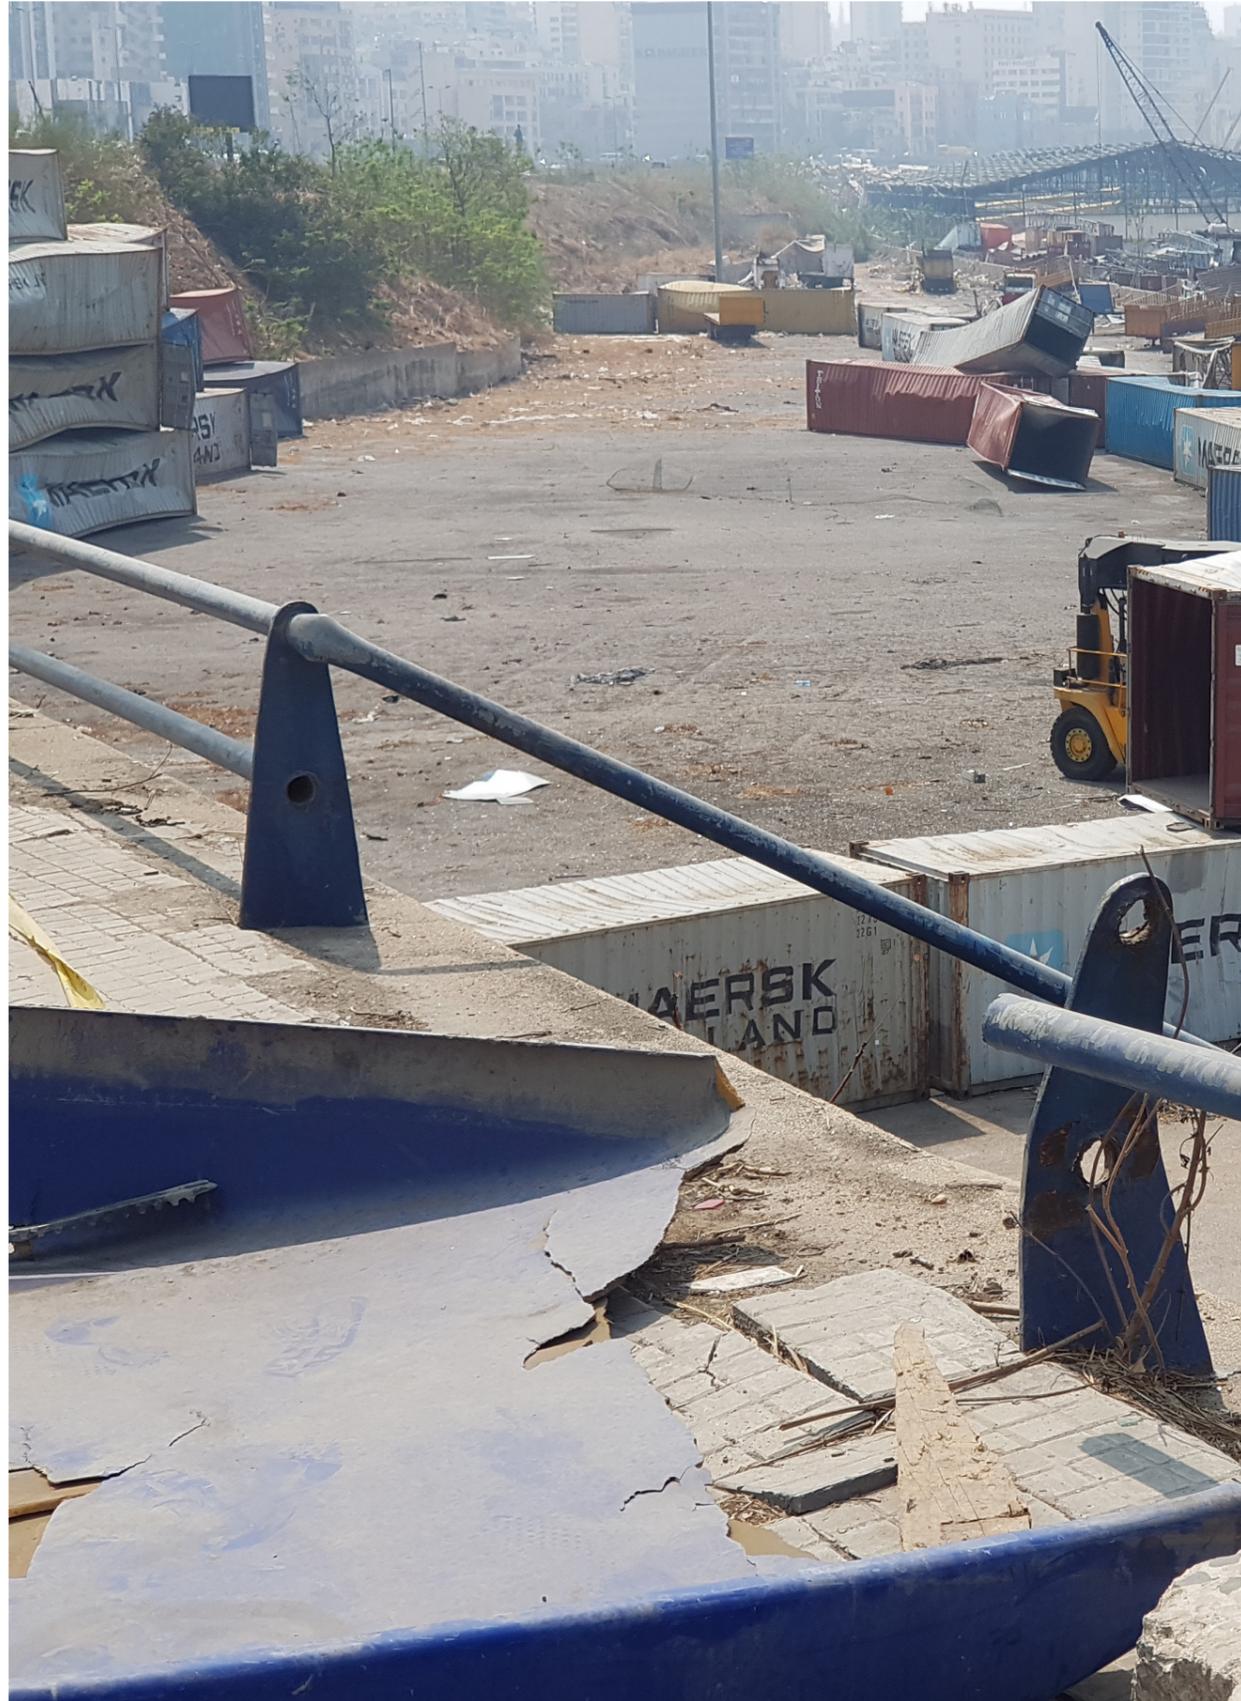
Figure 1.3. Damaged Fence

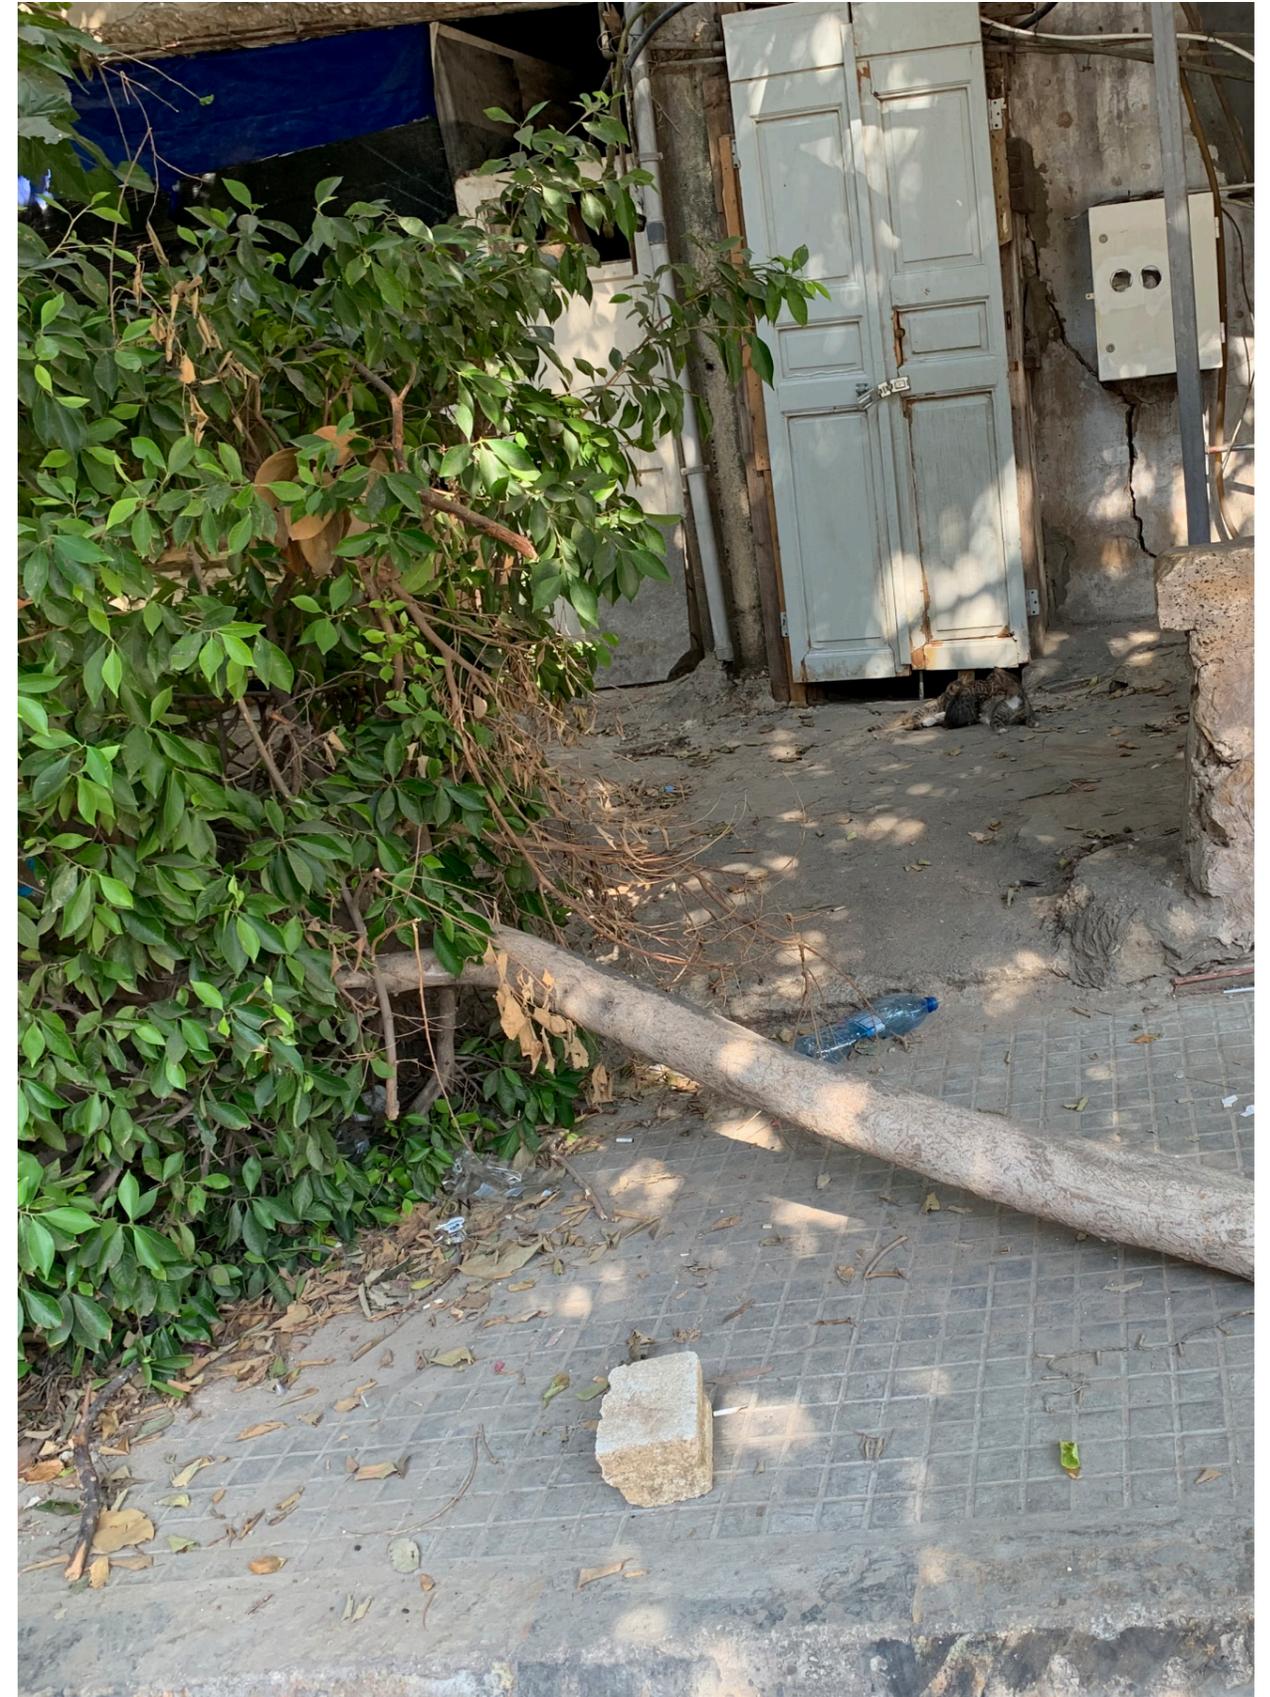
Figure 1.4. Damaged Tree

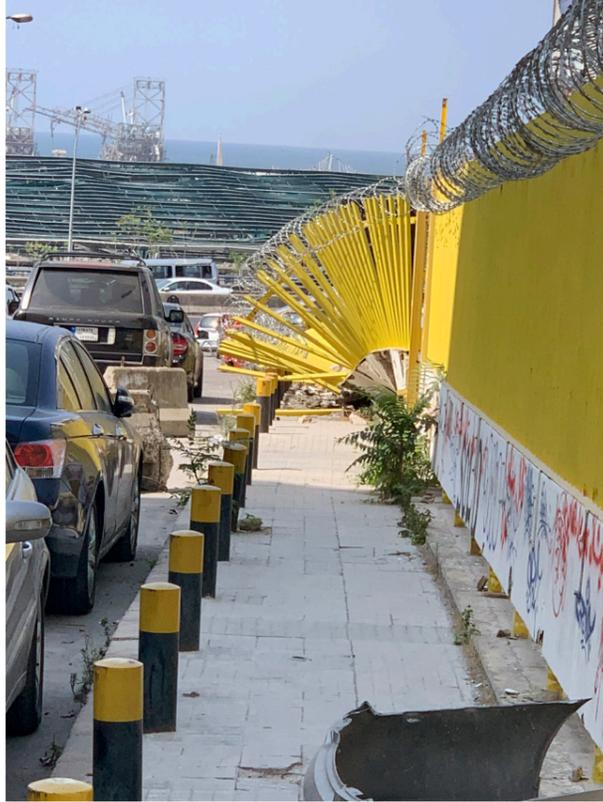
Figure 1.5. Tilted Fence of Électricité Du Liban

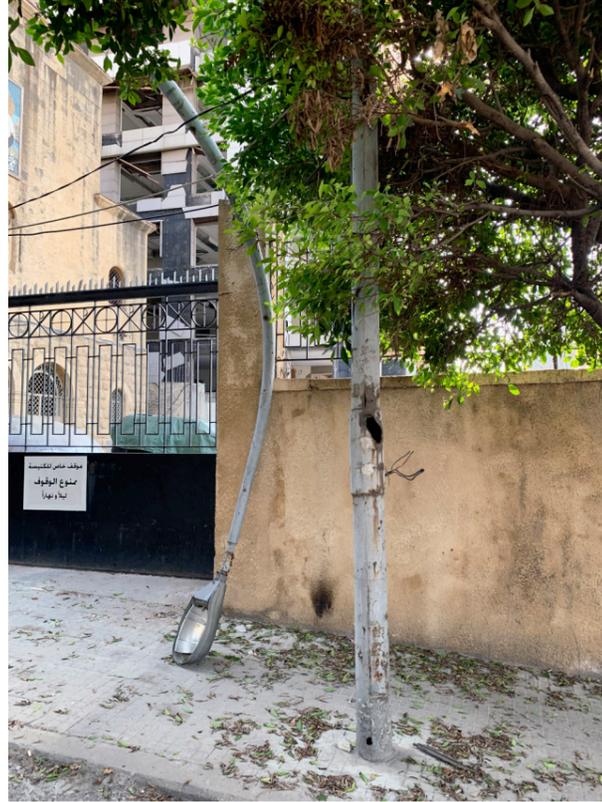
Figure 1.6. Broken Light Pole

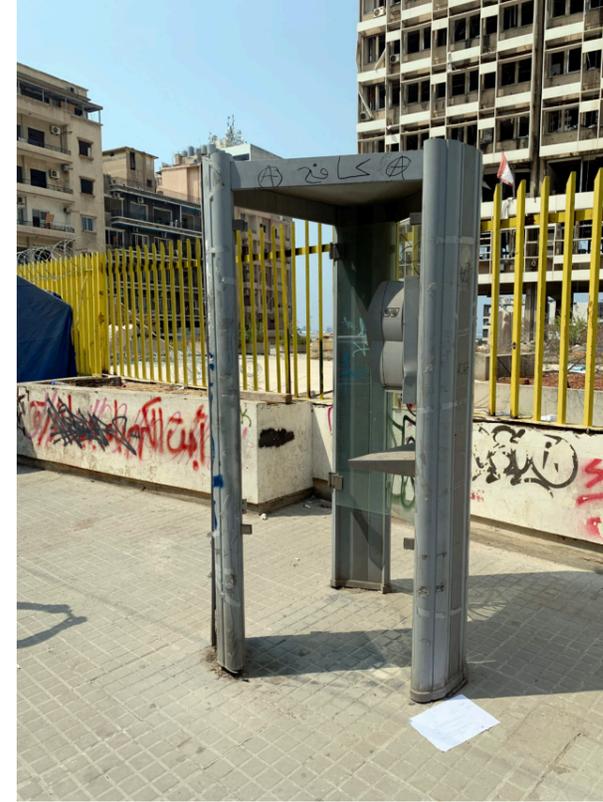
Figure 1.8. Broken Glass of Phone Booth

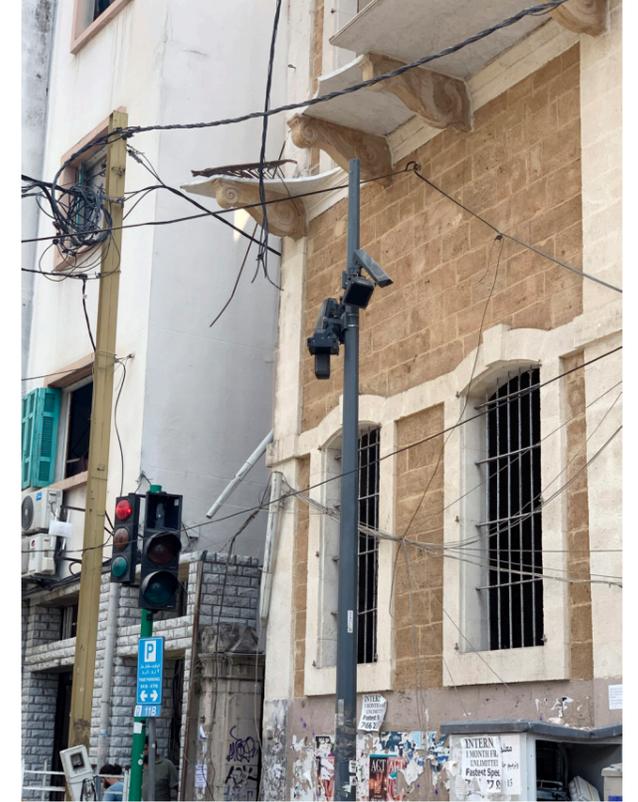
Figure 1.9. Broken Traffic Light

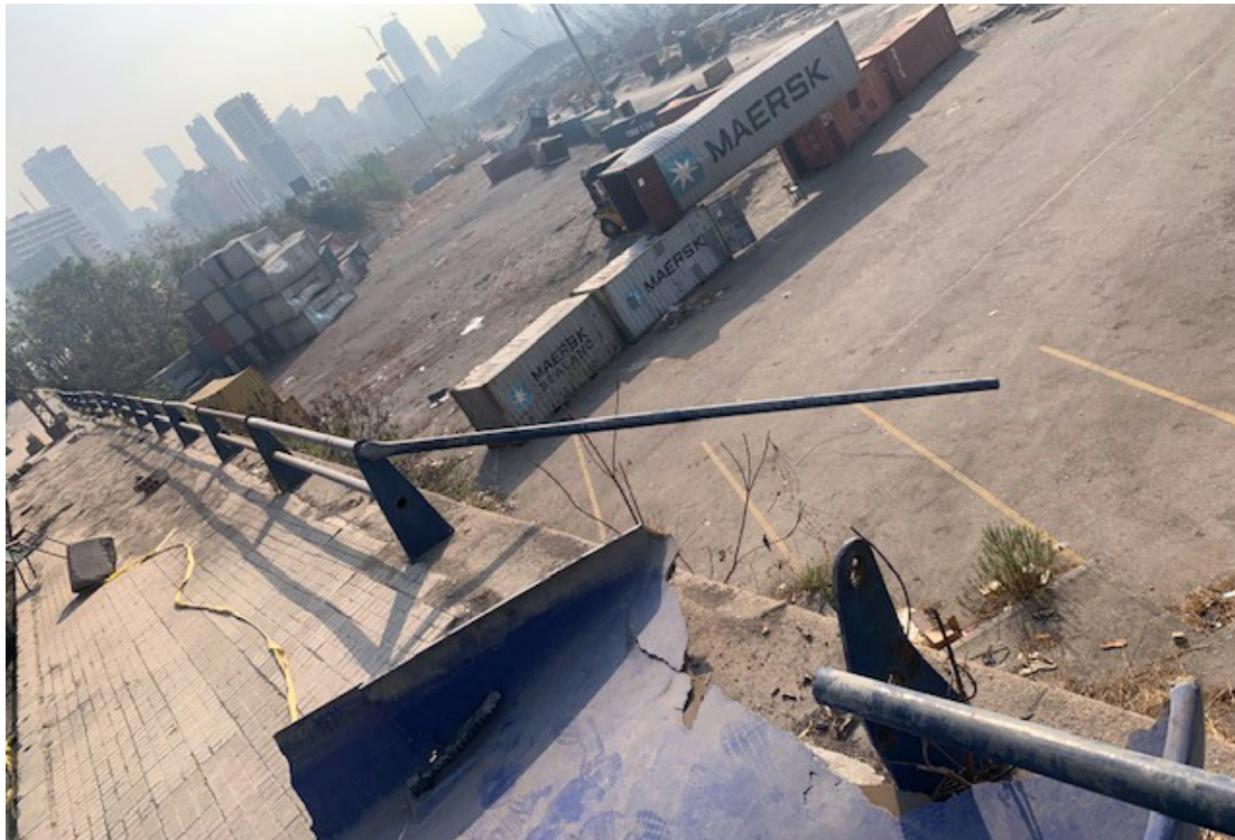
Figure 1.7. Destroyed Fence Adjacent to the Port

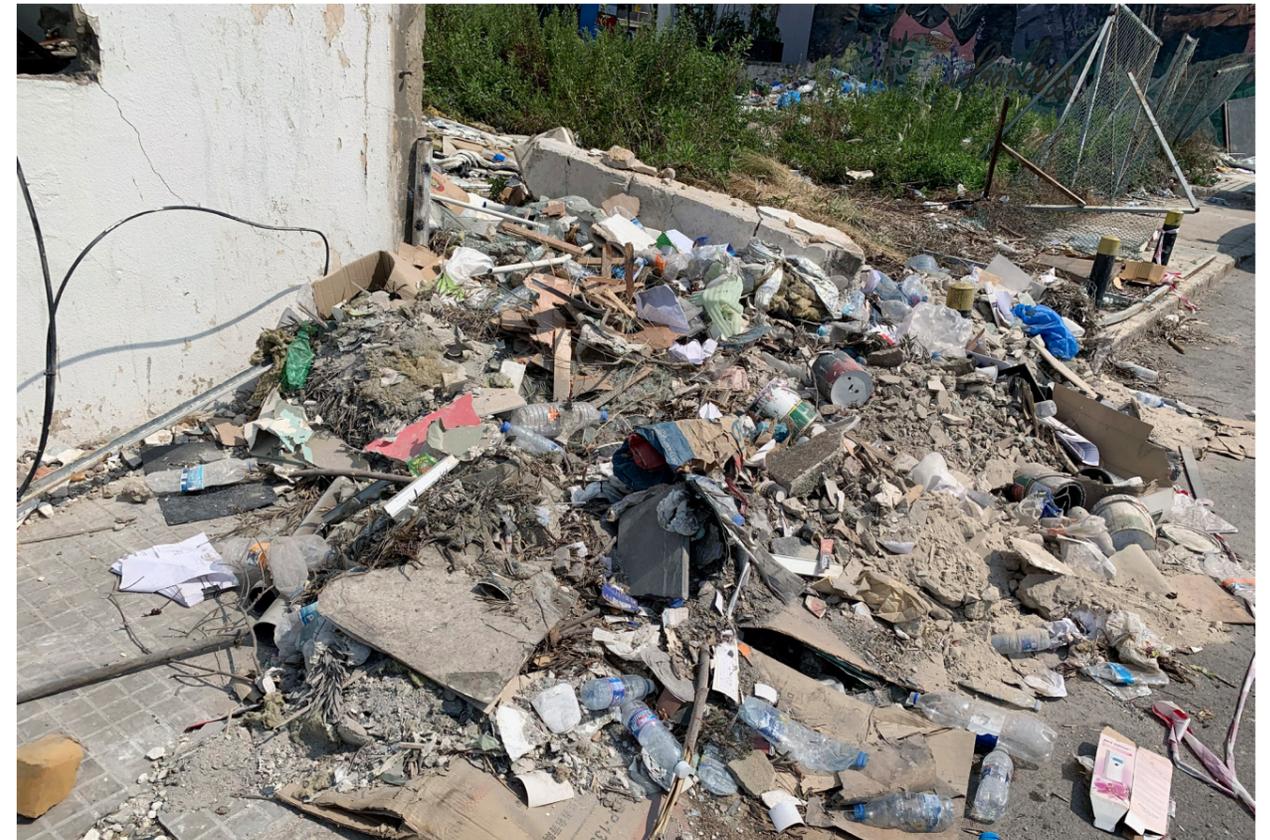
Figure 1.10. Demolition Waste Placed on Sidewalk Constitutes a Hazard for Pedestrians

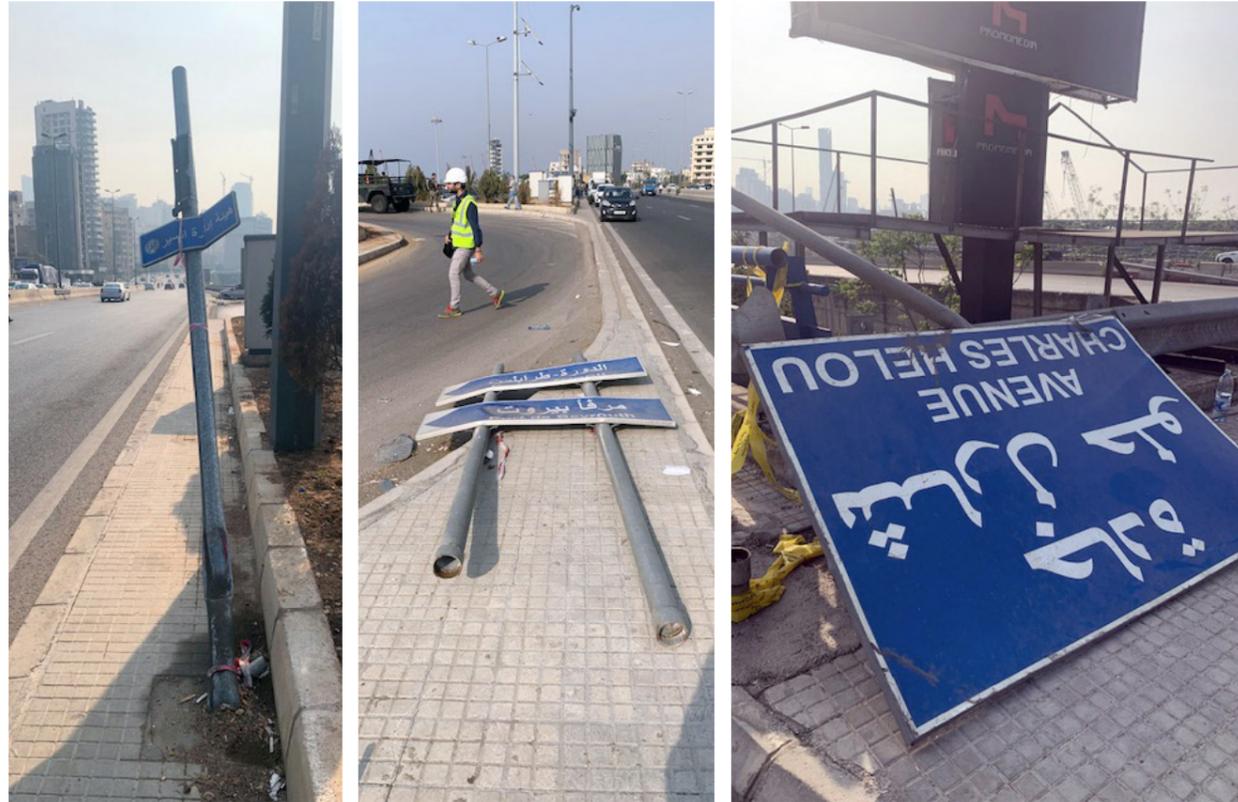
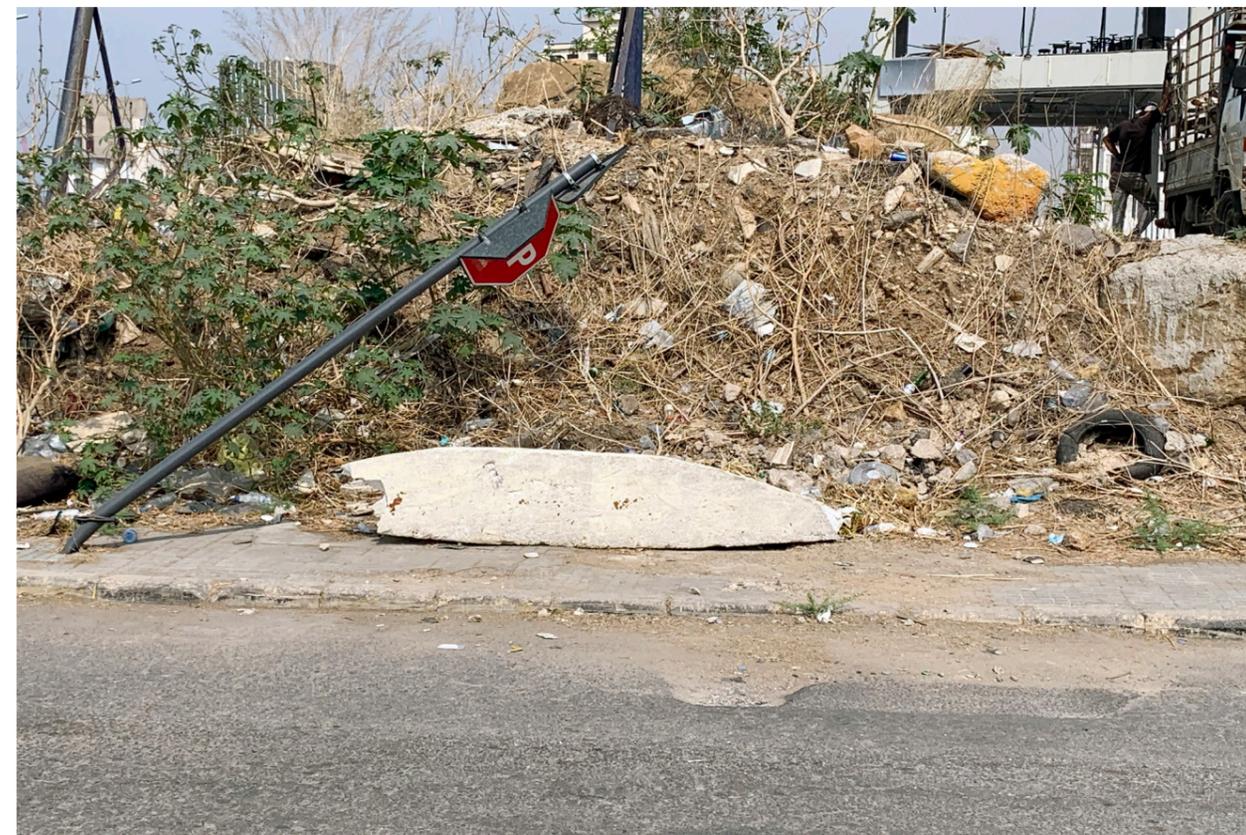
Figure 1.11. Destroyed Signage

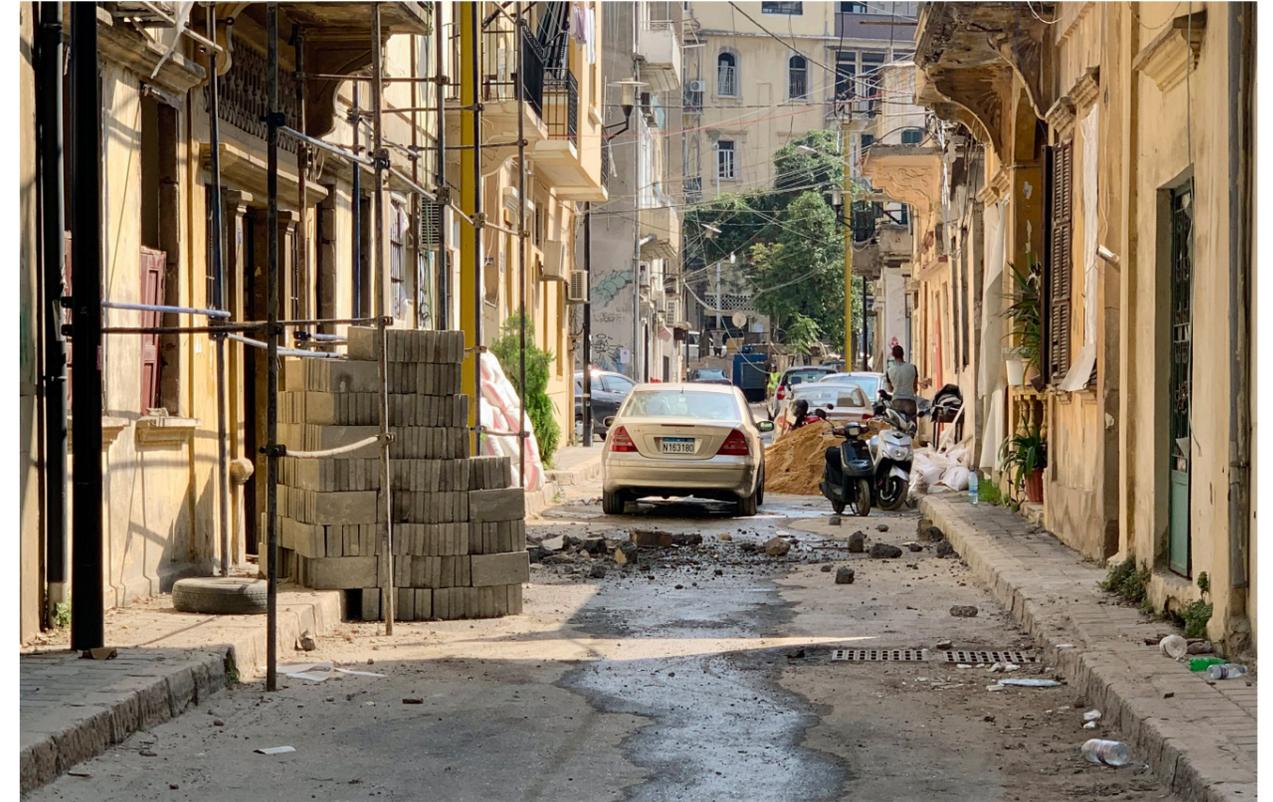
Figure 1.12. Absence of Any Protection for Pedestrians During Reconstruction

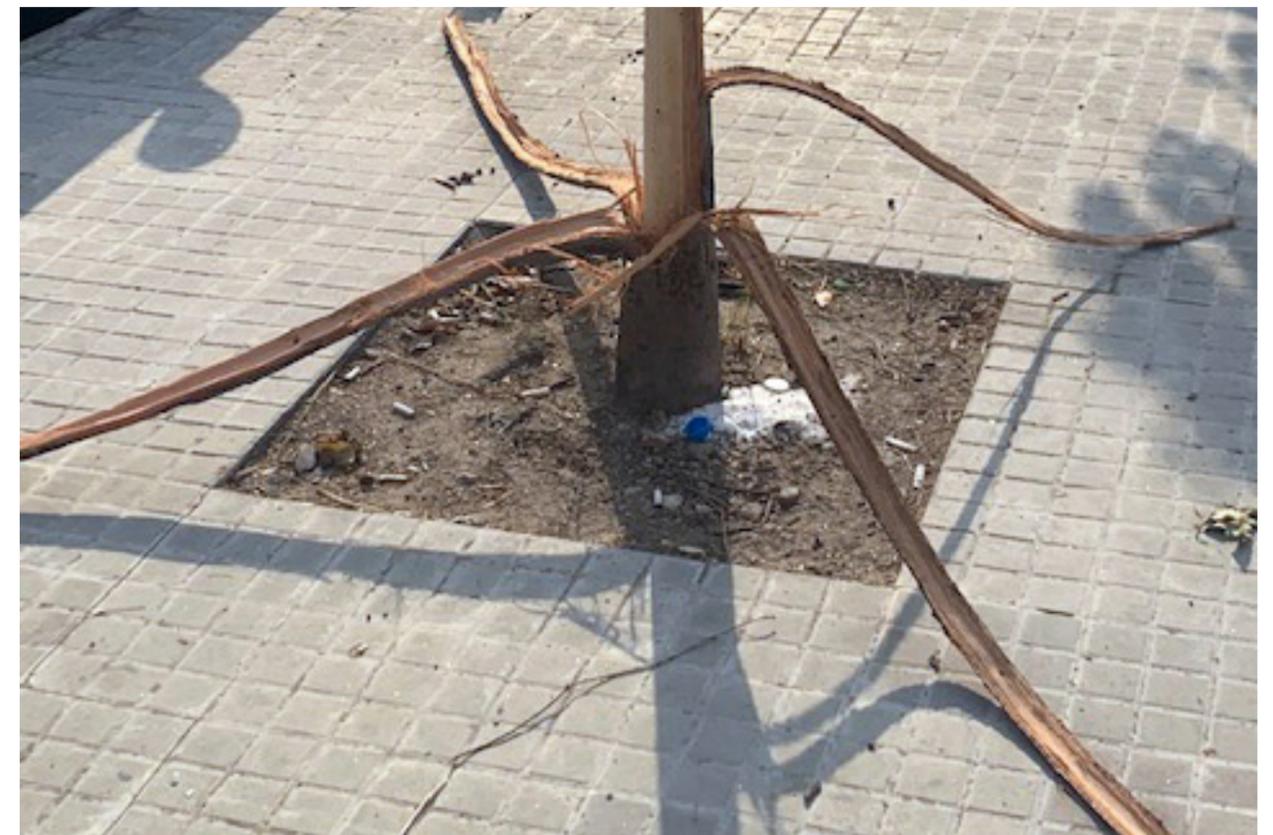
Figure 1.13. Damaged Tree Bark

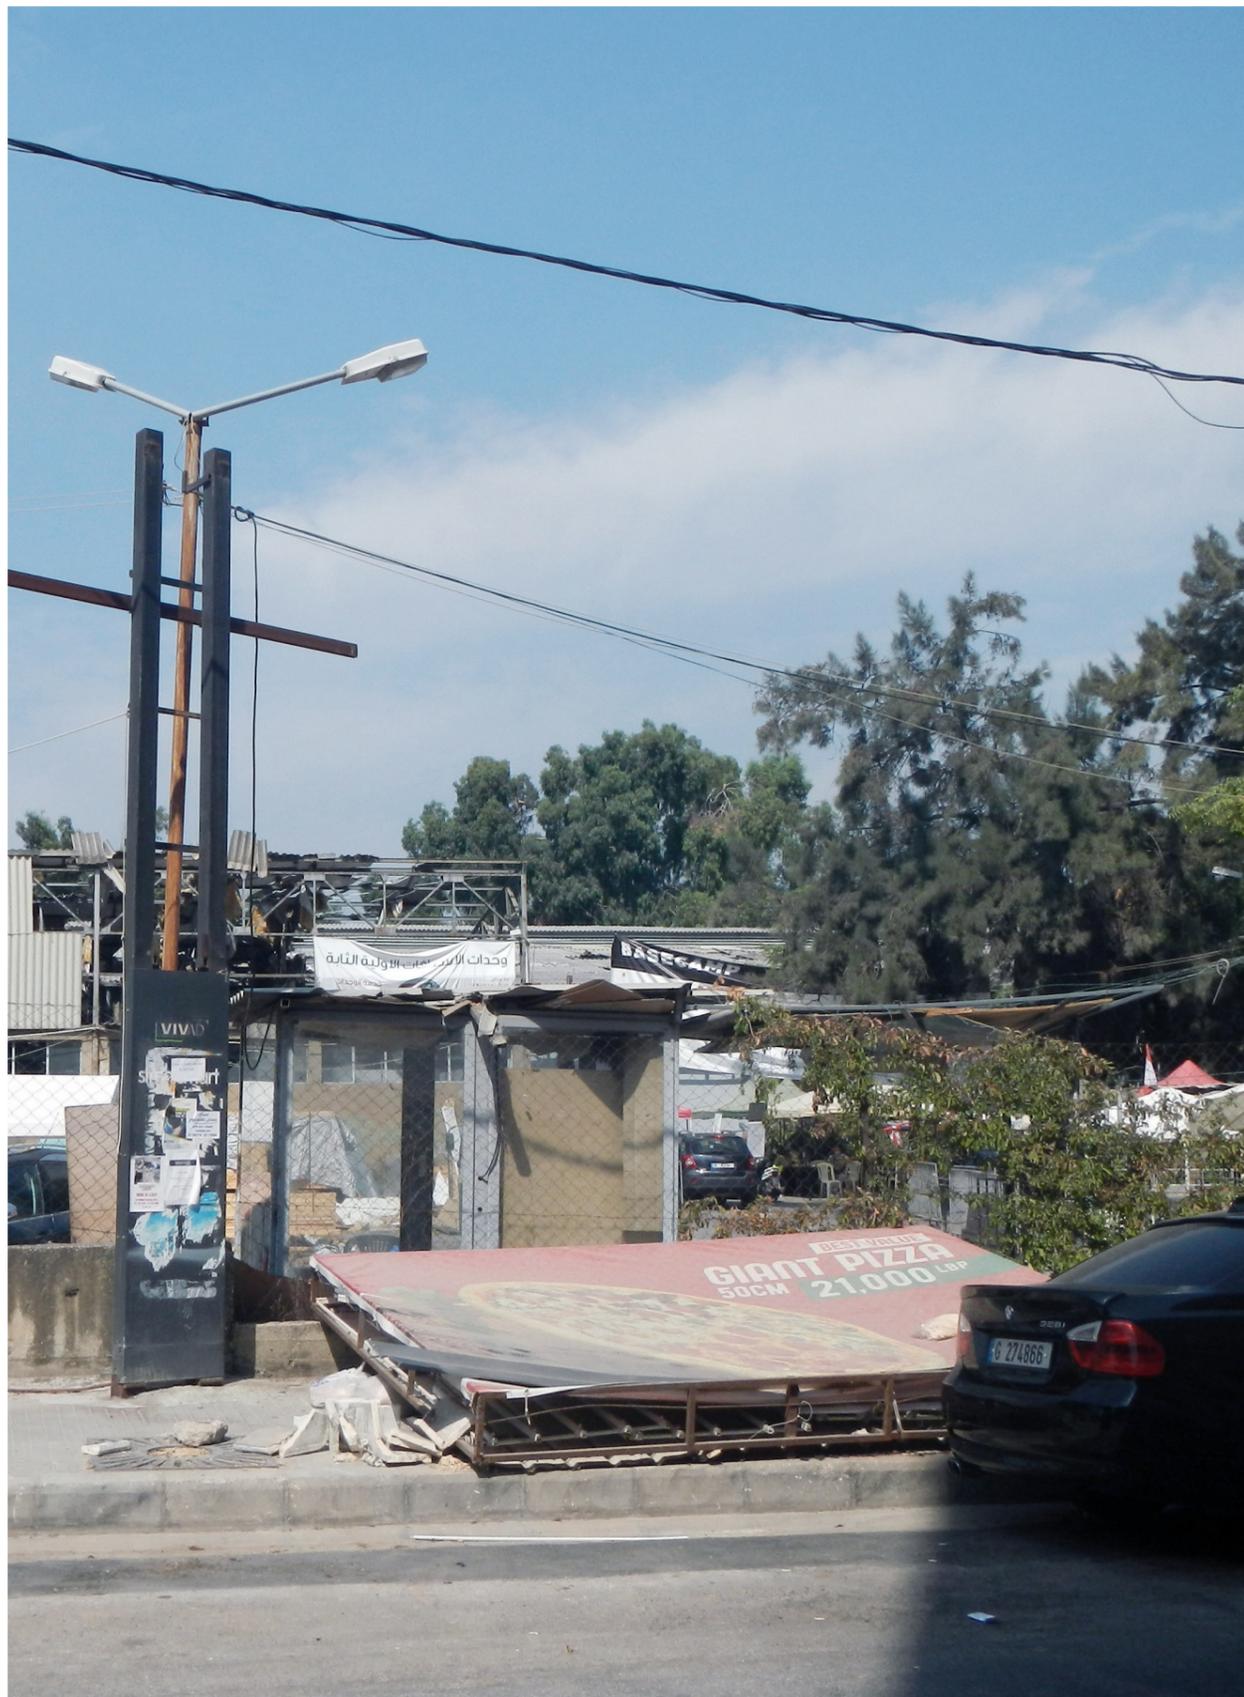
Figure 1.14. Destroyed Advertisement Board

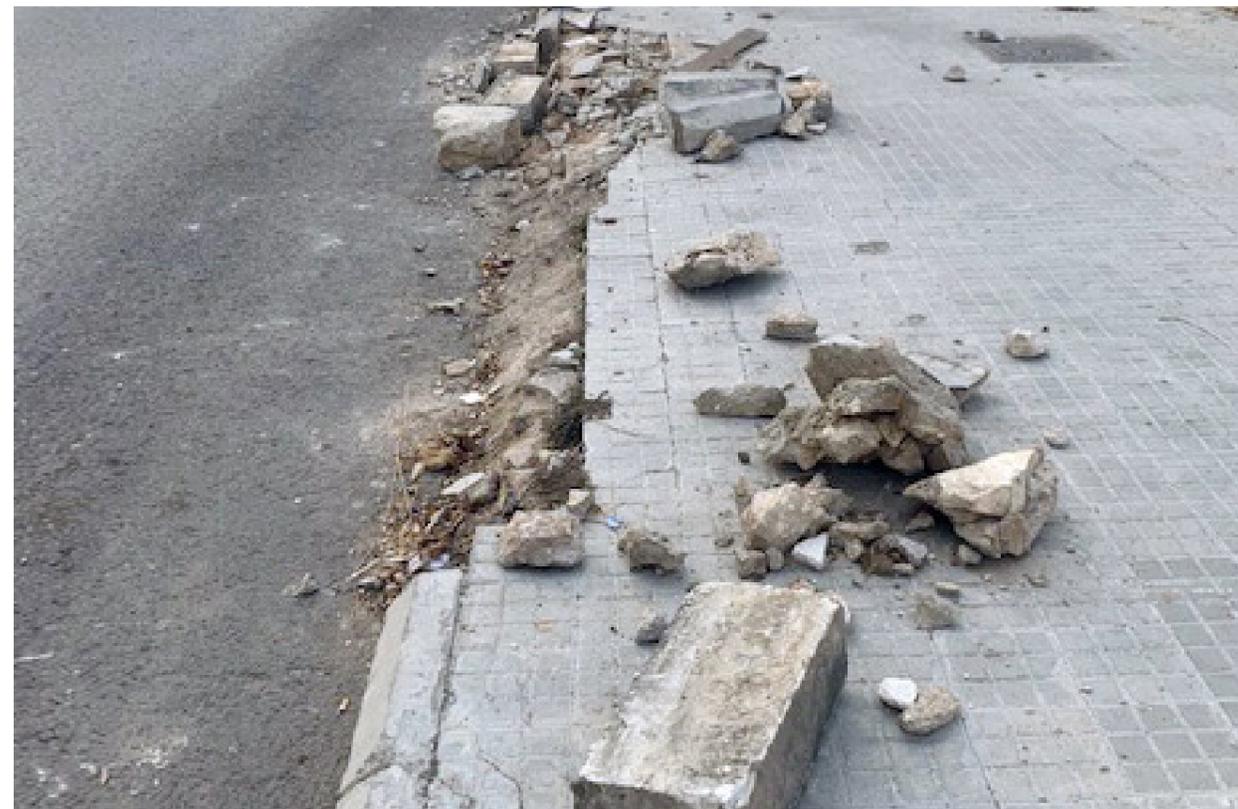
Figure 1.15. Damaged Curbs and Pavers (1)

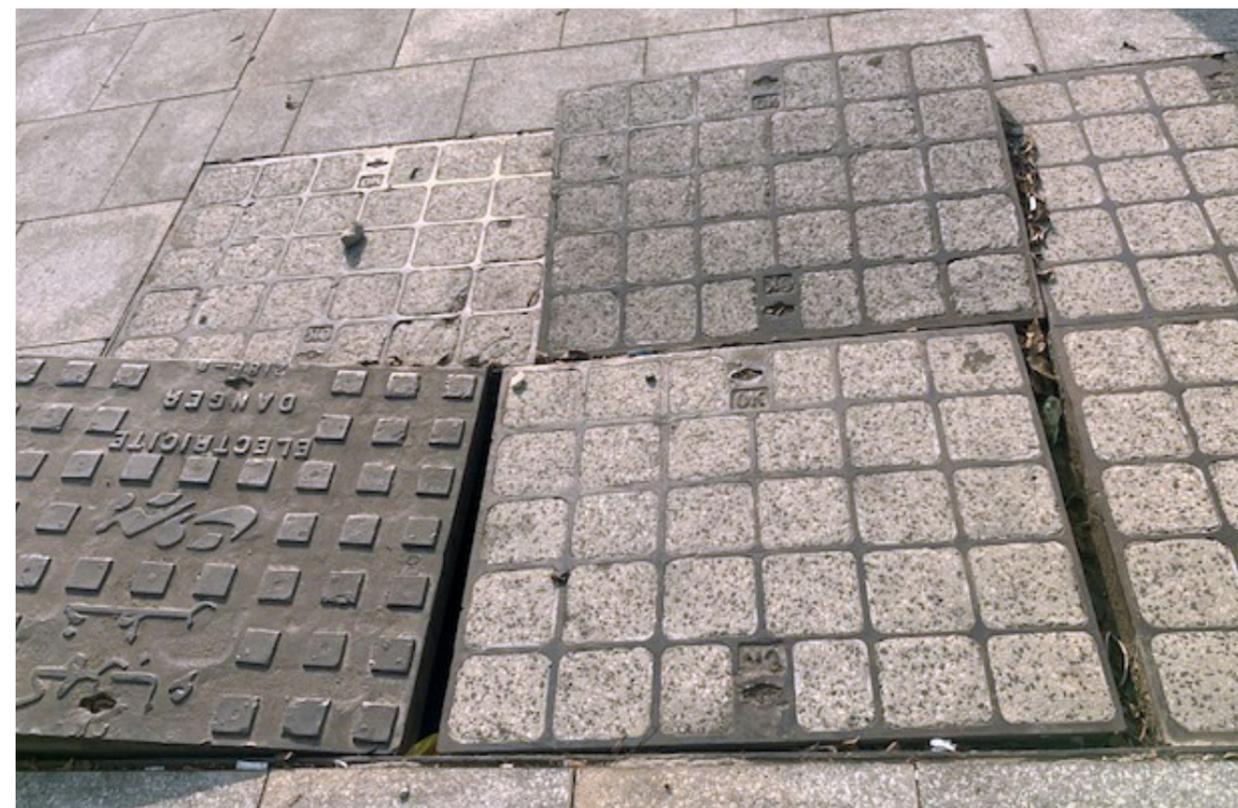
Figure 1.16. Damaged Curbs and Pavers (2)

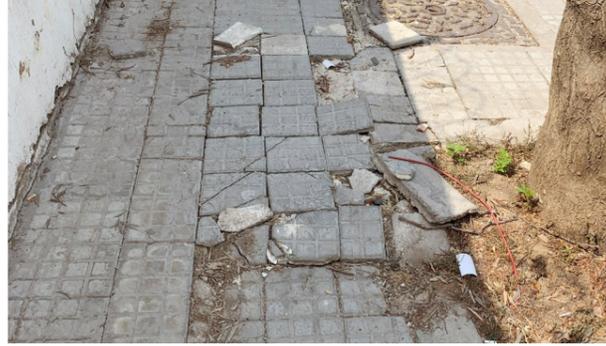
Figure 2.1. Pavers Broken By Overgrowth of Trees And Lack of Maintenance

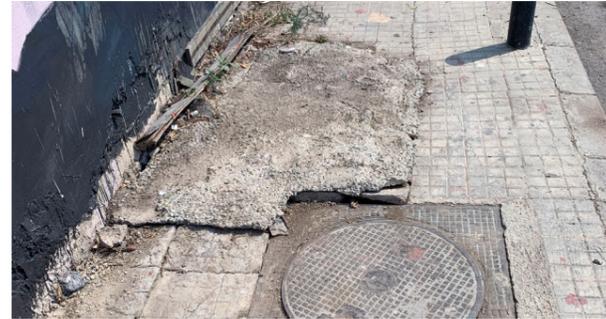
Figure 2.2. Additional Level of Concrete Above Pavers Creating a Hazard to Pedestrians

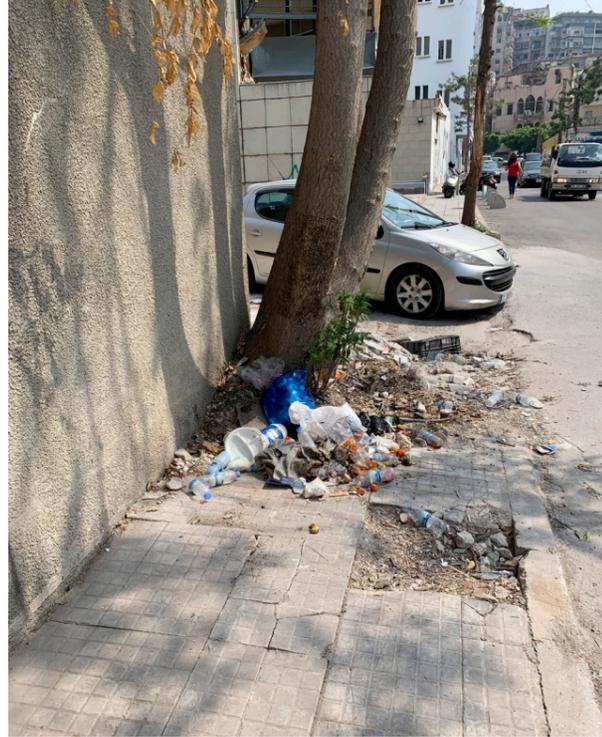
Figure 2.4. Sidewalk Used as Dump Site. Overgrowth of Trees at Perimeter Wall and Neglectfully Installed Pavement are Additional Signs of the Absence of Guidelines and Proper Planning for Safe, Walkable Sidewalks

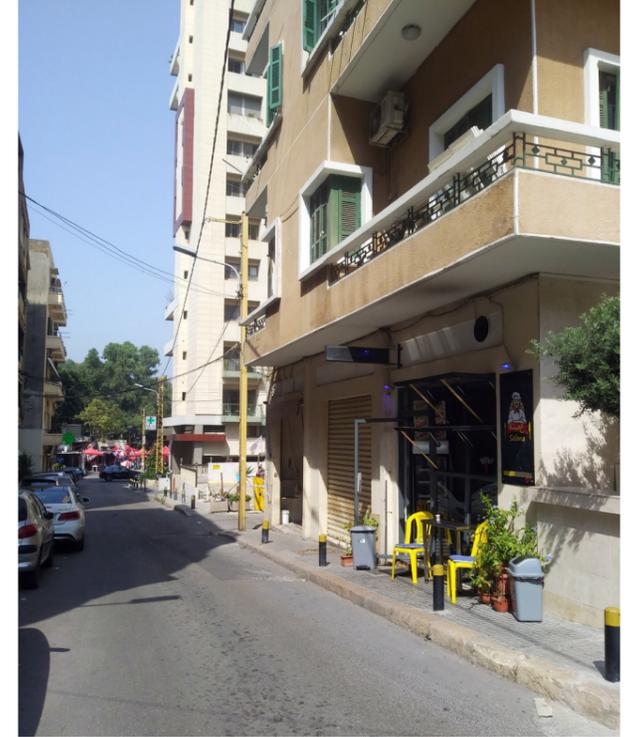
Figure 2.8. Restaurant Seating and Chairs Encroaching on the Already Narrow Sidewalk (2)

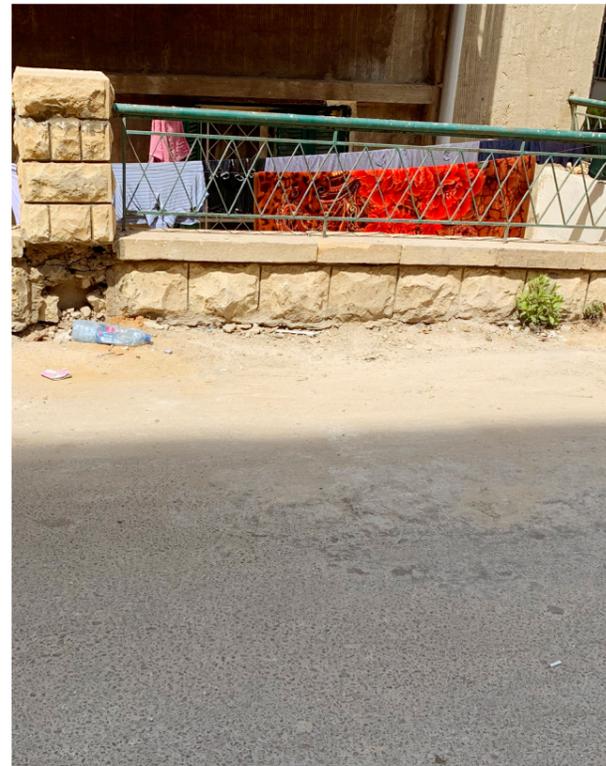
Figure 2.3. Total Absence of Sidewalks

1. Widening sidewalks so as to completely discourage informal parking. If a road already has a width that can afford informal parking then that space should be reclaimed for pedestrian use. Lining the sidewalks with bollards, and preferably with planters and trees, would additionally discourage parking on the pavement itself.
2. Replacing asphalt on primary roads with permeable asphalt and on secondary and tertiary roads with permeable pavements or cobblestone. The permeable materials would tackle rainwater runoff and street flooding, while the use of pavers and cobblestone would designate shared spaces or pedestrian priority spaces. The use of such materials has also been known to discourage speeding.
3. Designing zebra crossings or crossing ramps especially for busier roads, so to minimize possible pedestrian and vehicular conflicts.

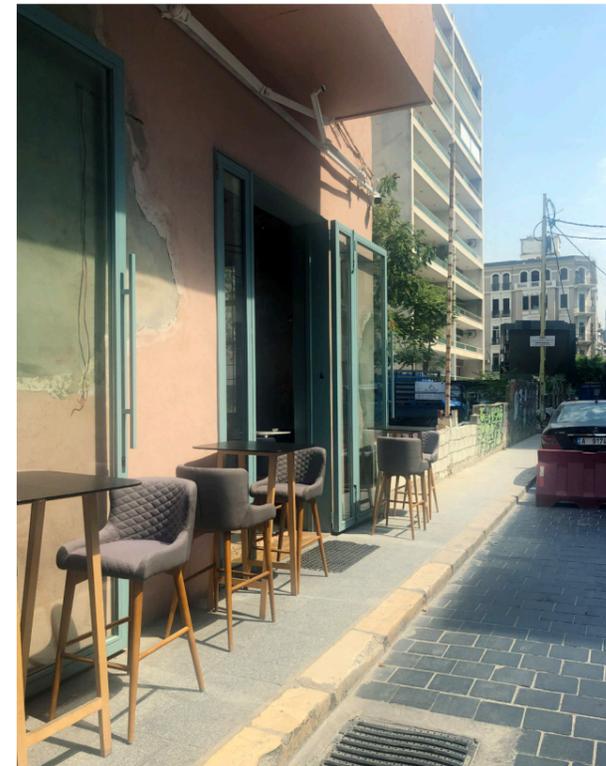
Figure 2.7. Restaurant Seating and Chairs Encroaching on the Already Narrow Sidewalk (1)

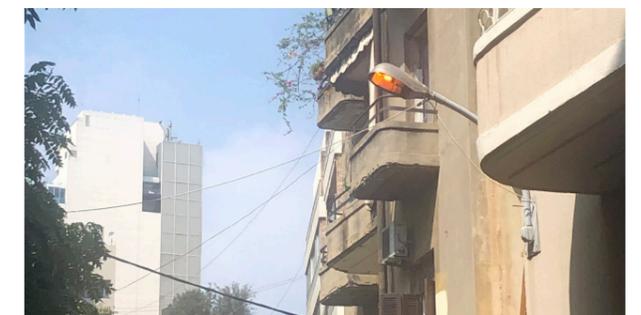
Figure 2.10. Wasted Electrical Output for Street Lighting During the Day

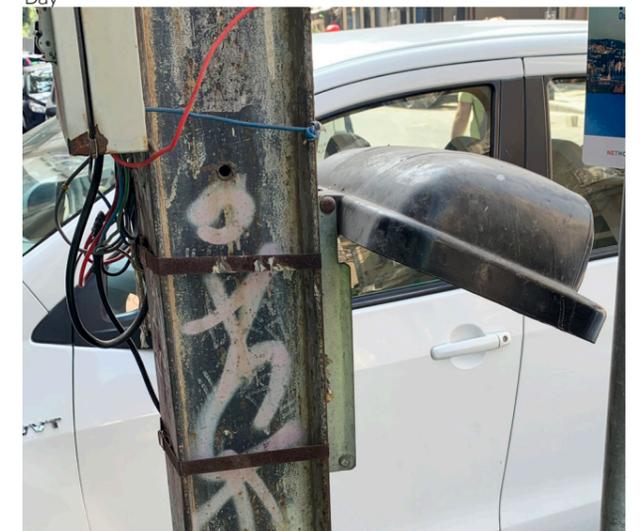
Figure 2.11. Hazards from Electric Cables (1)

1. Explore the feasibility of moving all utilities, especially electrical, to underground culverts. If that is not feasible then the electric grid needs to be rearranged and organized in such a way that cables no longer crisscross across streets or come in direct contact with residents. Perhaps building walls and roofs could act as cable conduits, and cables can be encased in metal or concrete channels along such flat spaces.
2. Study the existing location of street bins following a walking distance evaluation (radius of 200m to 400m, which account for walking distances of 2-3 minutes and 5 minutes respectively) and

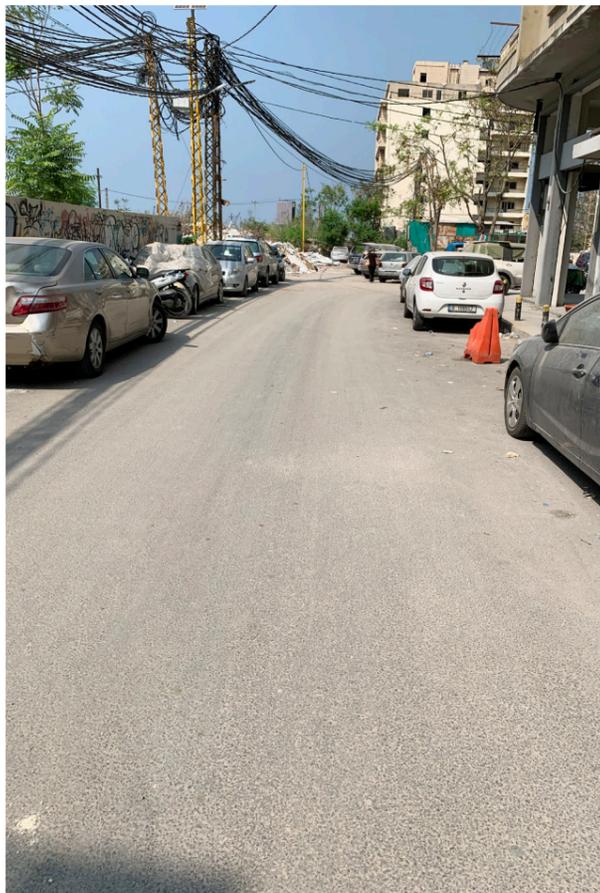
Figure 2.12. Hazards From Electric Cables (2)
