BEIRUT

— OPEN SPACE POST- DISASTER DAMAGE AND PRE-DISASTER CONDITION ASSESSMENT

SEPTEMBER 2020

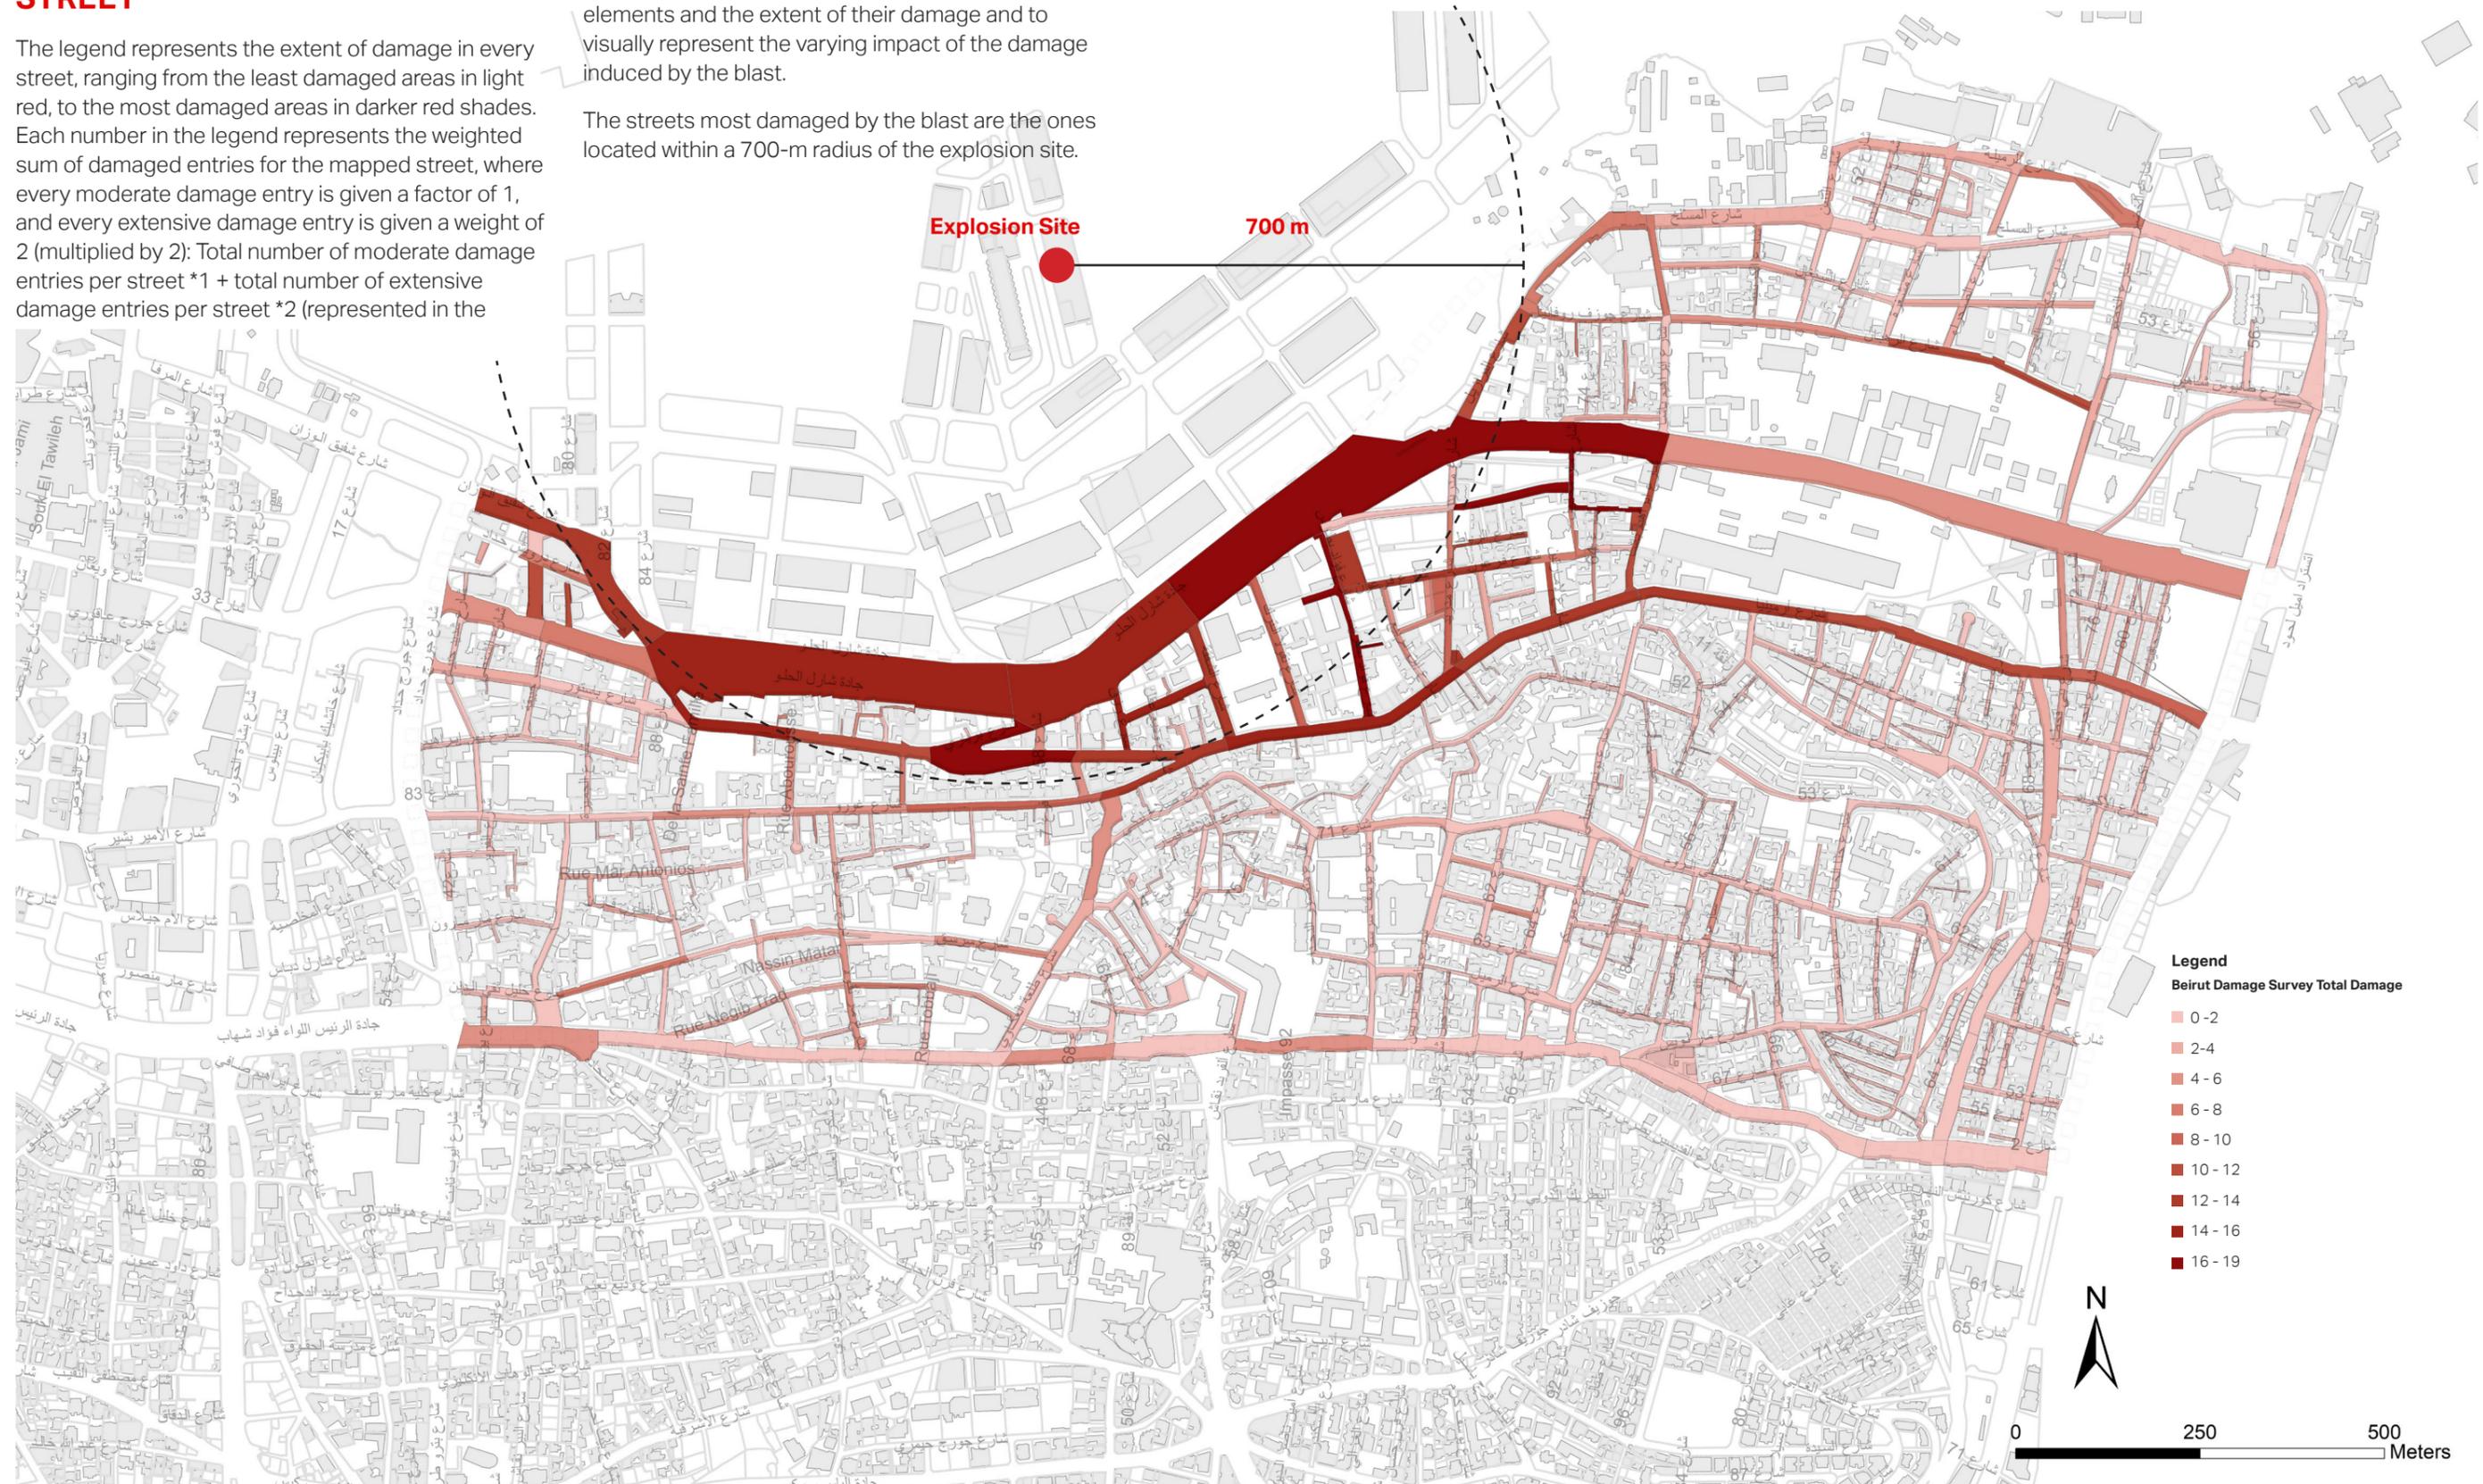
Figure 1.1. Heat Map Showing Level of Damage Per Area

The streets most damaged by the blast are the ones located within a 700-m radius of the explosion site.

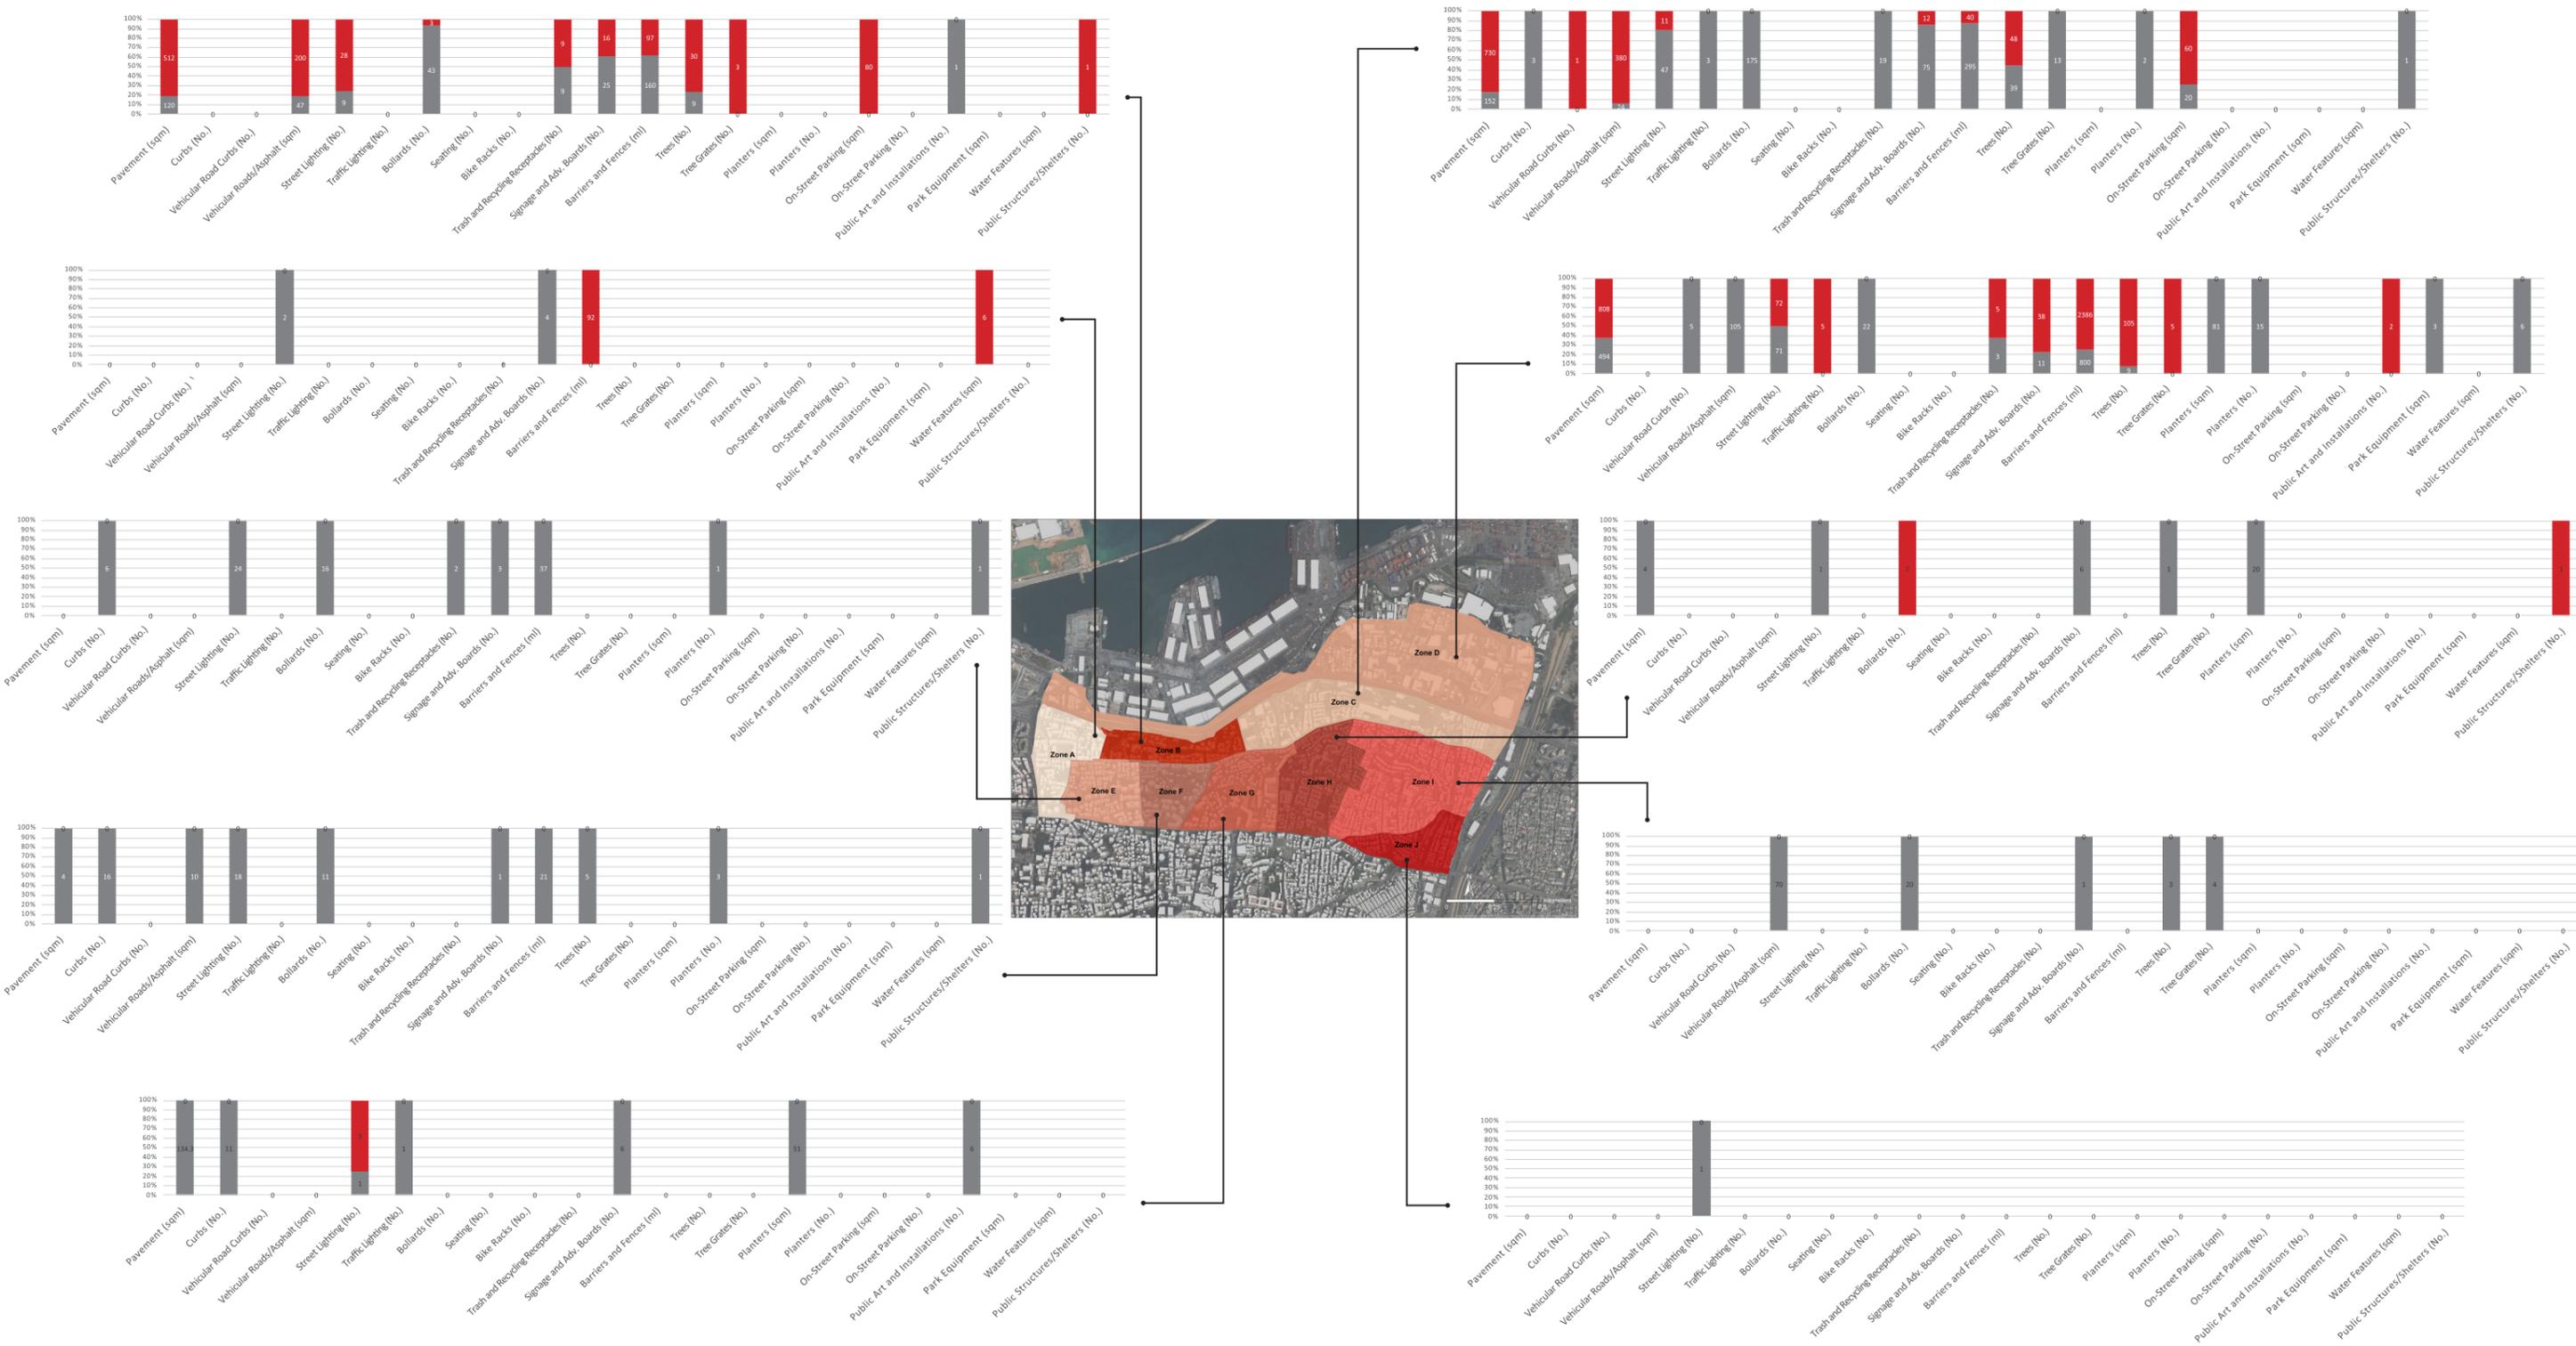
Figure 1.2. Level of Damage Per Element Per Zone

The below bar charts show the quantity of damaged elements, expressed in unit or meter linear or square meter, per level of damage (moderate and extensive) and per zone. The quantification of the damage allowed us to estimate the cost for repair and replacement.

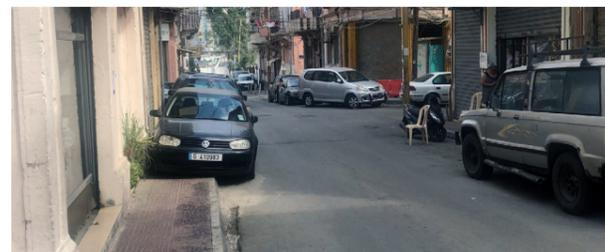
Considering the country's significant dependence on private vehicles due to a practically absent public transportation program, it should come as no surprise that informal parking in Beirut is a recurring trend in urban social behavior. This has only increased in the years since Gemmayzeh and Mar Mikhael transformed into nightlife and cultural hubs. Most streets exhibited one form or another of informal parking, some more invasive than others. As stated earlier, it was observed in many cases that cars would directly park on the sidewalk so as to create an informal parking spot without blocking car flow through the street. Even in roads where formal on-street parking had been designated, if roads were wide enough, car owners would park informally on the other side of the street as well and simply pay at the park meter as though it applied to the whole road. Most streets either had informal parking on one side or both sides, but very few had no cars parked at all.

Figure 2.9. Informal Parking on Sidewalks

1. Development of a feasible and low-cost public transport system for the north eastern quadrant of Beirut, preferably connecting to other districts in the city as well. This can be done through:
 - a. Establishing a park-and-ride network that employs buses;
 - b. Creating exclusive rights-of-way for buses and emergency vehicles; and/or
 - c. Rerouting the private car network so as to liberate certain streets that are in turn used exclusively for pedestrian and bus movement.
2. Provision of parking nodes, perhaps multistory parking facilities (over-ground or underground) at key plots of land that are large enough for such a purpose, so as to provide a more suitable number of parking spots for residents and users. Such facilities can be refurbished and reclaimed as useful space for other functions and programs in the future if car ownership and dependency

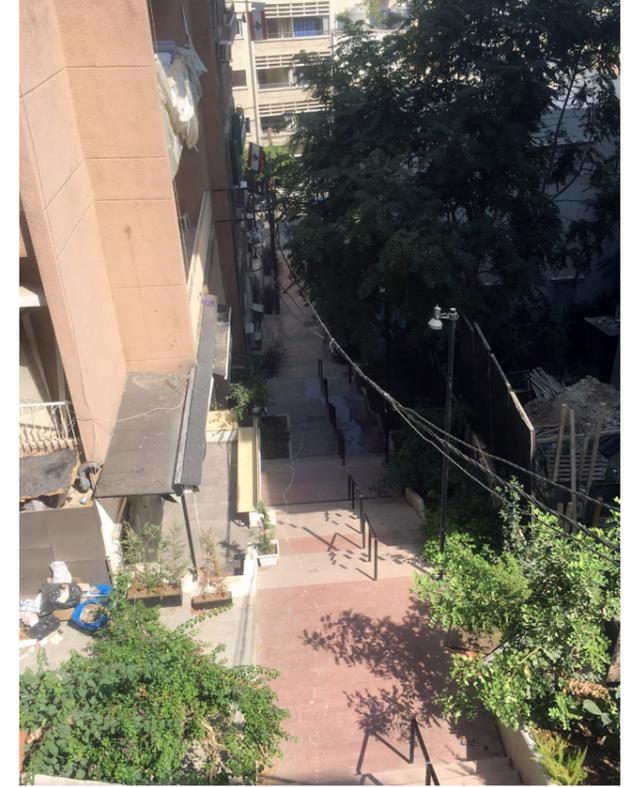
Figure 2.14. Historic, Charming Steps that can be Enhanced (2)

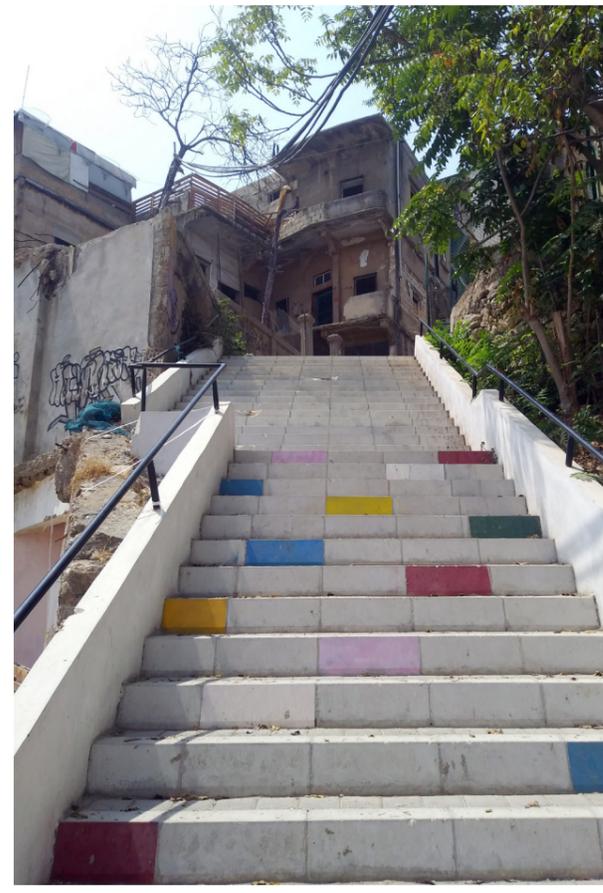
Figure 2.13. Historic, Charming Steps that can be Enhanced (1)

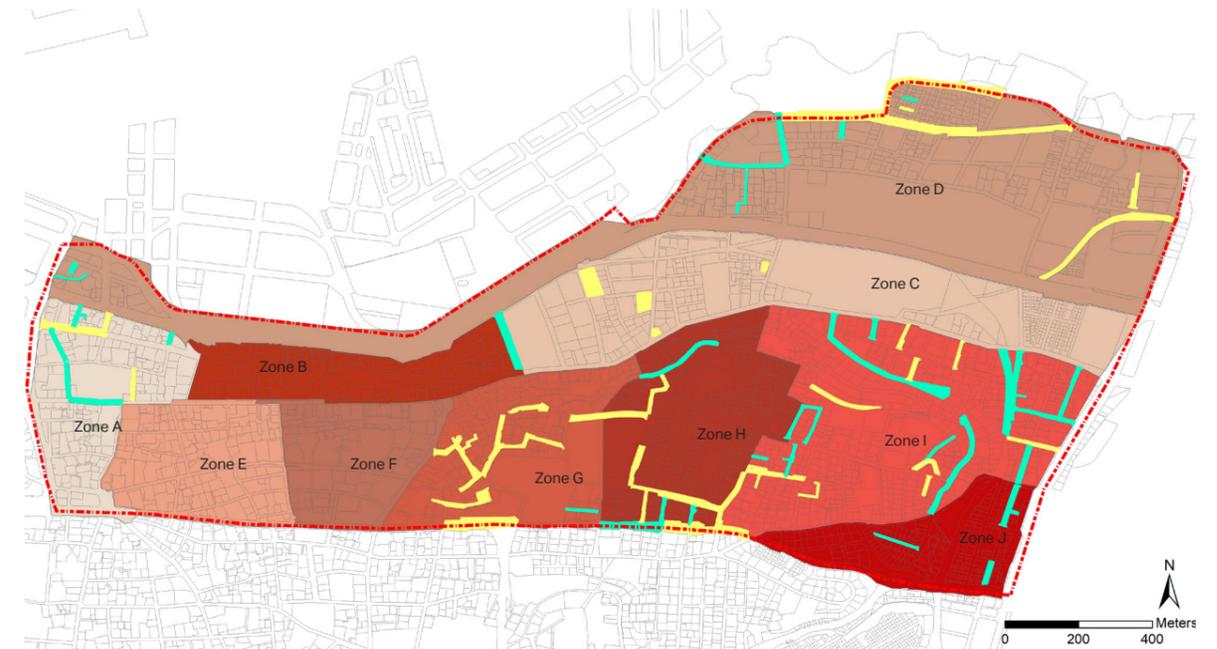
The ratio of vacant lots and parking areas to green spaces is overwhelming high in the area of study, almost 10 to 1 in fact according to the survey. The majority of these lots and parking areas are privately owned. Vacant lots have been appropriated in most cases as make-shift parking areas, but some interesting cases were found where they had been turned into social spaces and make-shift gardens/orchards. Many of them show signs of long-standing neglect and abandonment, having been reclaimed by wild vegetative growth that has not been tended to in years.

Figure 2.15. Street Stretches with Vacant and Parking Lots

2. Explore with land owners, the municipality, and local religious institutions (waqf land owners), the potential to convert a number of their lands or portions of their plots to green pockets, parks, or social spaces. Perhaps donation booths can be set up for such a purpose or agreements with municipal authorities on land tax incentives to encourage land owners.

3. Create a volunteer program for those interested in the maintenance and enhancement of new green pockets. These could be from the community itself, parishes of churches and users of local mosques, the municipality, or local scout groups and schools.

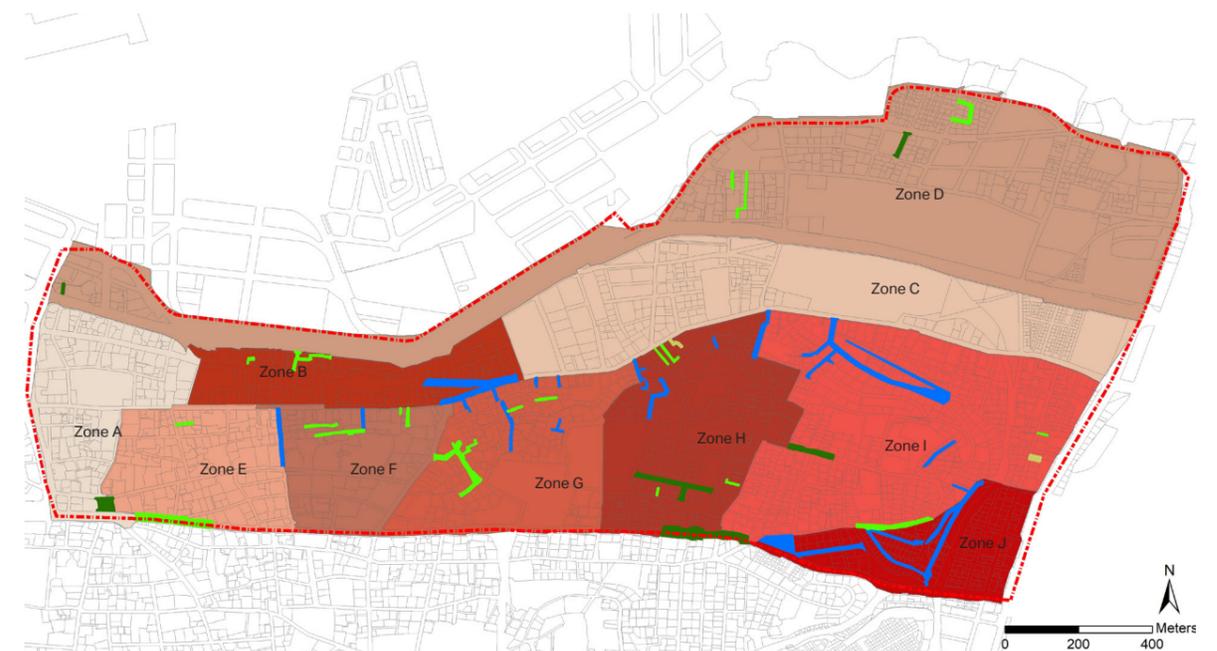
Figure 2.16. Street Stretches with Green Pockets, Public Steps and Pedestrian Alleyways
